2 December 2018

This letter outlines the results of a survey of vegetation condition undertaken by myself on the 30th November 2018 over part of Lot 3 Buller Rd, Waroona (herein referred to as the subject area). The purpose of the survey was to assess whether the vegetation condition within the subject area had returned, or was returning, to that which existed prior to the fire of January 2016 that also burnt large parts of the surrounding region.

Document No: 1815 Buller Rd Conservation Area,
Vegetation Condition Report V1

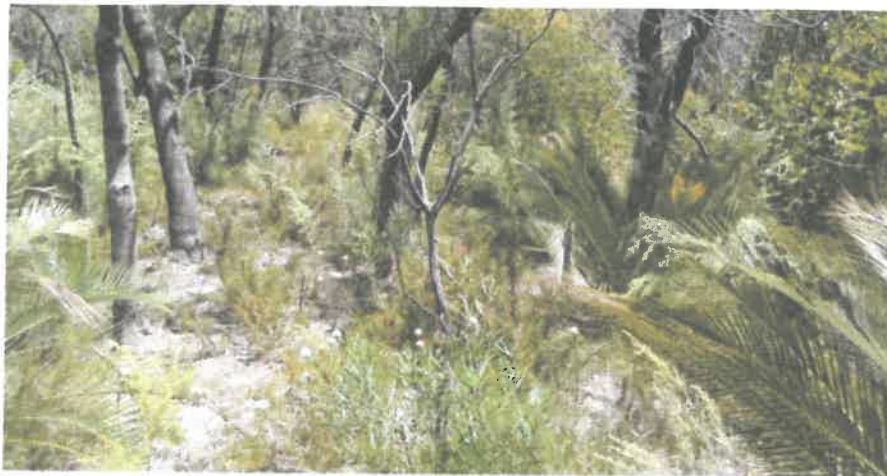
The condition of the vegetation in the southern half of the subject area was rated as 'Very Good', which is the same category as previously assigned by Woodman Environmental (2015) (Figures 1 and 2). The vegetation in this area is recovering its structure and diversity following the fire with a minor infestation of mainly non-aggressive weeds. Many native plants were observed to be resprouting and seedlings of *Banksia attenuata* were common. This area is a *Eucalyptus marginata* – *Banksia attenuata* woodland, and the vegetation

Plate 1: 'Very Good' vegetation showing native understorey with mid- and upper strata regenerating following fire (32.8634 S, [115.8229 E](#)).

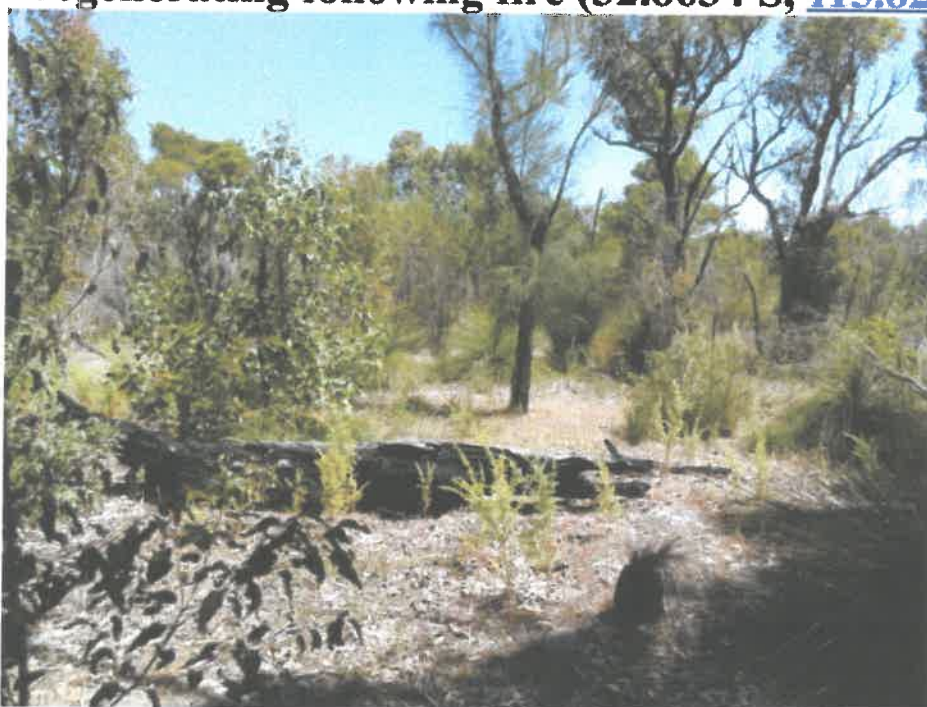
Plate 2: 'Very Good' vegetation, showing more open understorey but few weeds and intact vertical structure (32.8954 S, [115.8299 E](#)).

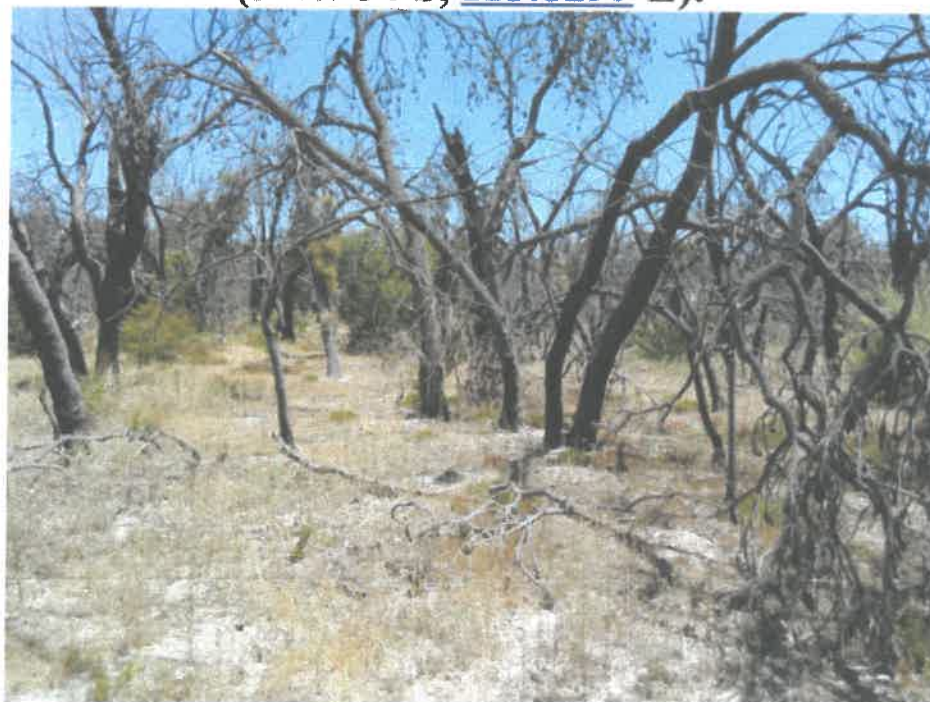
The vegetation of the northern half of the site was mostly in a 'Completely Degraded' to 'Degraded' condition. The original vegetation structure has been largely lost and the understorey is dominated by weed species (Figure 3). This area had been rated as 'Degraded' by Woodman Environmental (2015) and the fire may have adversely affected the vegetation even further. As such, the northern part of the subject area does not meet the criteria to be considered part of the Banksia Woodlands TEC. There were some small parts of the northern section that could be rated as 'Good', as the basic vertical structure is still intact but weeds dominated the understorey (Figure 4). The 'Good' areas mostly coincided with those mapped in the same category by Woodman Environmental (2015). While there is a degree of subjectivity in the rating of vegetation condition and may vary between observers, it is clear the vegetation condition in most of the northern part of the subject area has not improved since the fire and may have declined further.

Plate 3: 'Completely Degraded' vegetation with almost no ground layer and very open upper canopy (32.8553 S, [115.8233 E](#)).

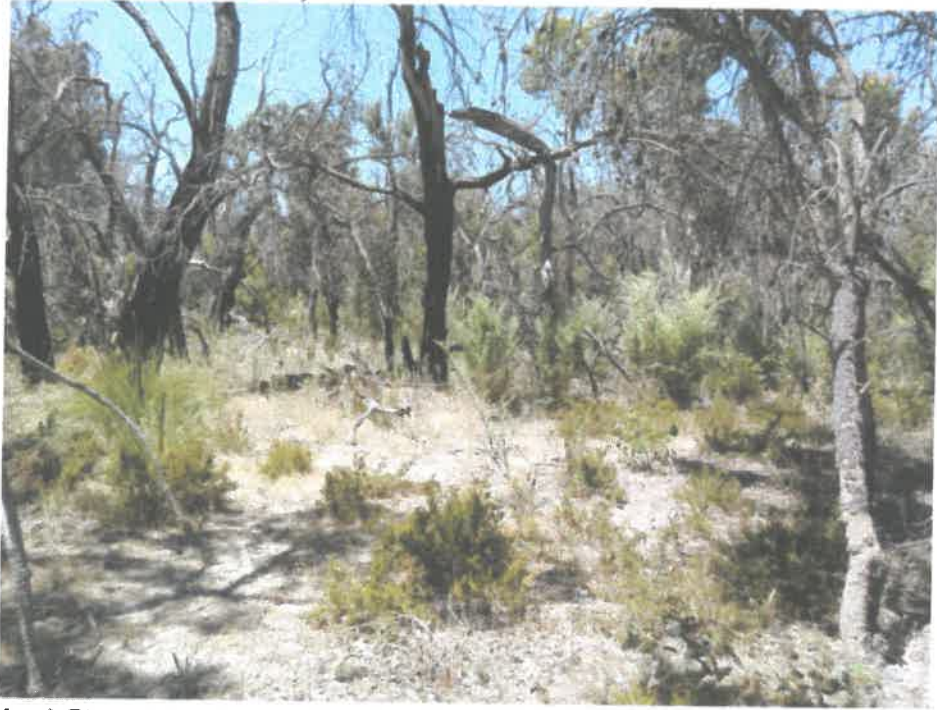
Plate 4: 'Good' vegetation with a weedy understorey and some native species, but vertical structure is still present (32.8589 S, [115.8227 E](#)).
