2 December 2018

This letter outlines the results of a survey of vegetation condition undertaken by myself on the 30th November 2018 over part of Lot 3 Buller Rd, Waroona (herein referred to as the subject area). The purpose of the survey was to assess whether the vegetation condition within the subject area had returned, or was returning, to that which existed prior to the fire of January 2016 that also burnt large parts of the surrounding region.

Document No: 1815 Buller Rd Conservation Area,
Vegetation Condition Report V1

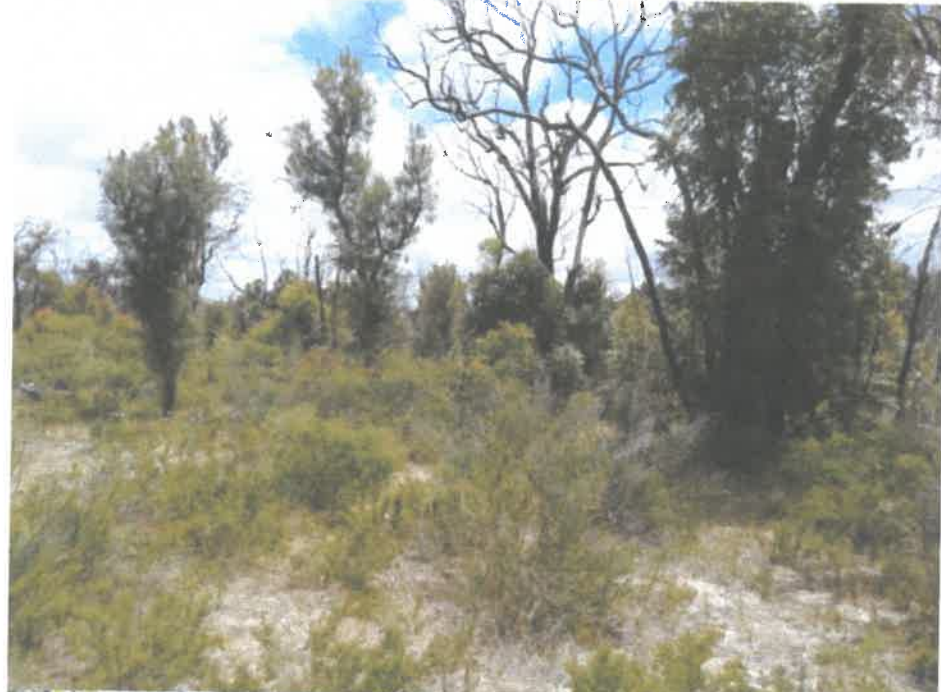
The condition of the vegetation in the southern half of the subject area was rated as 'Very Good', which is the same category as previously assigned by Woodman Environmental (2015) (Figures 1 and 2). The vegetation in this area is recovering its structure and diversity following the fire with a minor infestation of mainly non-aggressive weeds. Many native plants were observed to be resprouting and seedlings of *Banksia attenuata* were common. This area is a *Eucalyptus marginata* – *Banksia attenuata* woodland, and the vegetation

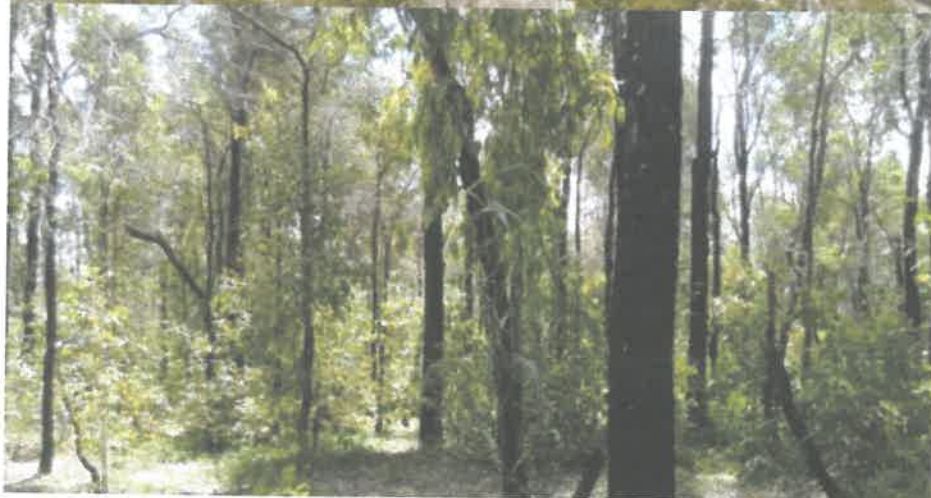
The vegetation of the northern half of the site was mostly in a 'Completely Degraded' to 'Degraded' condition. The original vegetation structure has been largely lost and the understorey is dominated by weed species (Figure 3). This area had been rated as 'Degraded' by Woodman Environmental (2015) and the fire may have adversely affected the vegetation even further. As such, the northern part of the subject area does not meet the criteria to be considered part of the Banksia Woodlands TEC. There were some small parts of the northern section that could be rated as 'Good', as the basic vertical structure is still intact but weeds dominated the understorey (Figure 4). The 'Good' areas mostly coincided with those mapped in the same category by Woodman Environmental (2015). While there is a degree of subjectivity in the rating of vegetation condition and may vary between observers, it is clear the vegetation condition in most of the northern part of the subject area has not improved since the fire and may have declined further.
